Service Instruction Number SIN2348 Revision M

Installation, Maintenance, and Repair of the KAflex®
Driveshaft for the Bell 206A and 206B Helicopter.

KAMATICS CORPORATION SERVICE INSTRUCTION NUMBER 2348

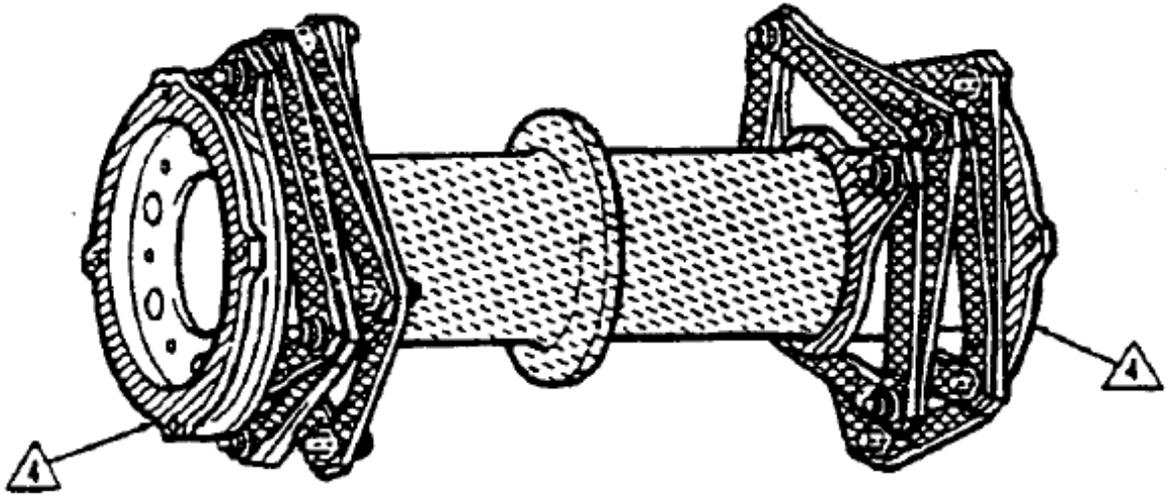
FIGURE 5: Damage Limits – KAFlex Driveshaft

1. Refer to Figure 5 for repair criteria. All blends shall be smooth at maximum depth and smoothly blended with surrounding surfaces.
2. The KAflex Driveshaft is not field overhauled. The KAflex Driveshaft can only be disassembled for inspection at Kamatics Corporation.
3. The KAflex Driveshaft is to be removed at 6,000 hours and sent to Kamatics Corporation for complete factory overhaul and inspection as required.

MECHANICAL	0.001" before and after repair	0.005" before and after repair	0.005" before and after repair	0.015" before and after repair
CORROSION	Surface, no pits	0.005" before and after repair	0.005" before and after repair	0.010" before and after repair
MAXIMUM AREA PER FULL DEPTH REPAIR	0.05 in ²	0.10 in ²	0.25 in ²	0.25 in ²
NUMBER OF REPAIRS	One per leg			
EDGE DENTS, NICKS	0.001 in	0.010 in	0.010 in	0.025 in

1. No cracks are permitted
2. Repairs must be no less than 1.000 inch apart.
3. Repairs not to be within 0.500 inches of bolt hole.
4. Faying surfaces must be free of any raised metal areas.

5. All repairs to be smooth at maximum depth and smoothly blended with surrounding surface.
6. Exposed bare metal may be touched up with products defined in drawing SKSP1500-TOUCHUP or Zinc Chromate, primer color T, even though it does not blend cosmetically with Sermetel coating, can be used if Sermetel touch-up products are unavailable.

9. If damage exceeds limit specified in this section, return driveshaft to Kamatics Corporation. Include description of reason for return and copy of Historical Record Card with the driveshaft.
