Service Instruction Number SIN2348 Revision M

Installation, Maintenance, and Repair of the KAflex®
Driveshaft for the Bell 206A and 206B Helicopter.

KAMATICS CORPORATION SERVICE INSTRUCTION NUMBER 2348

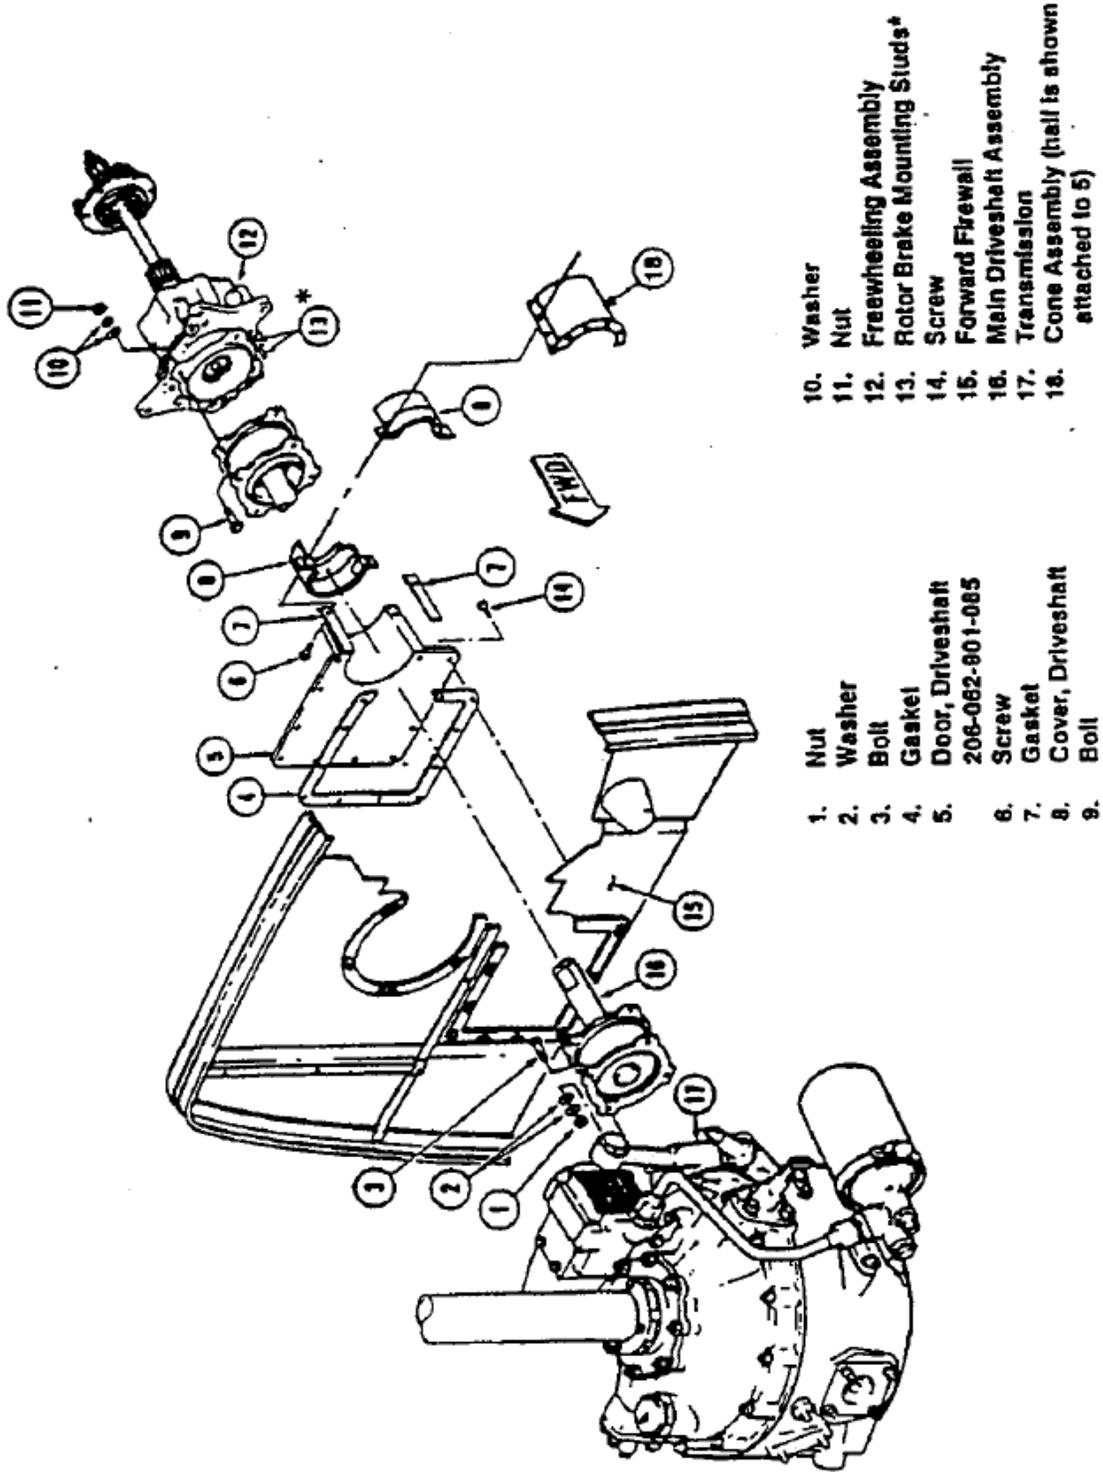
FIGURE 1: Existing Installation Main Driveshaft P/N 206-040-100-13

Inspect driveshaft door for cracks, damage and corrosion (Figure 1, Item 5). If these conditions exist, replace driveshaft door before proceeding.
