Service Instruction Number SIN2975 Revision C

Installation, Maintenance, and Repair of the KAflex® Rotor
Brake Kit for the Bell 206 A/B and 206B3 Helicopter.

KAMATICS CORPORATION SERVICE INSTRUCTION NUMBER 2975

Subject: KAflex Rotor Brake Retrofit

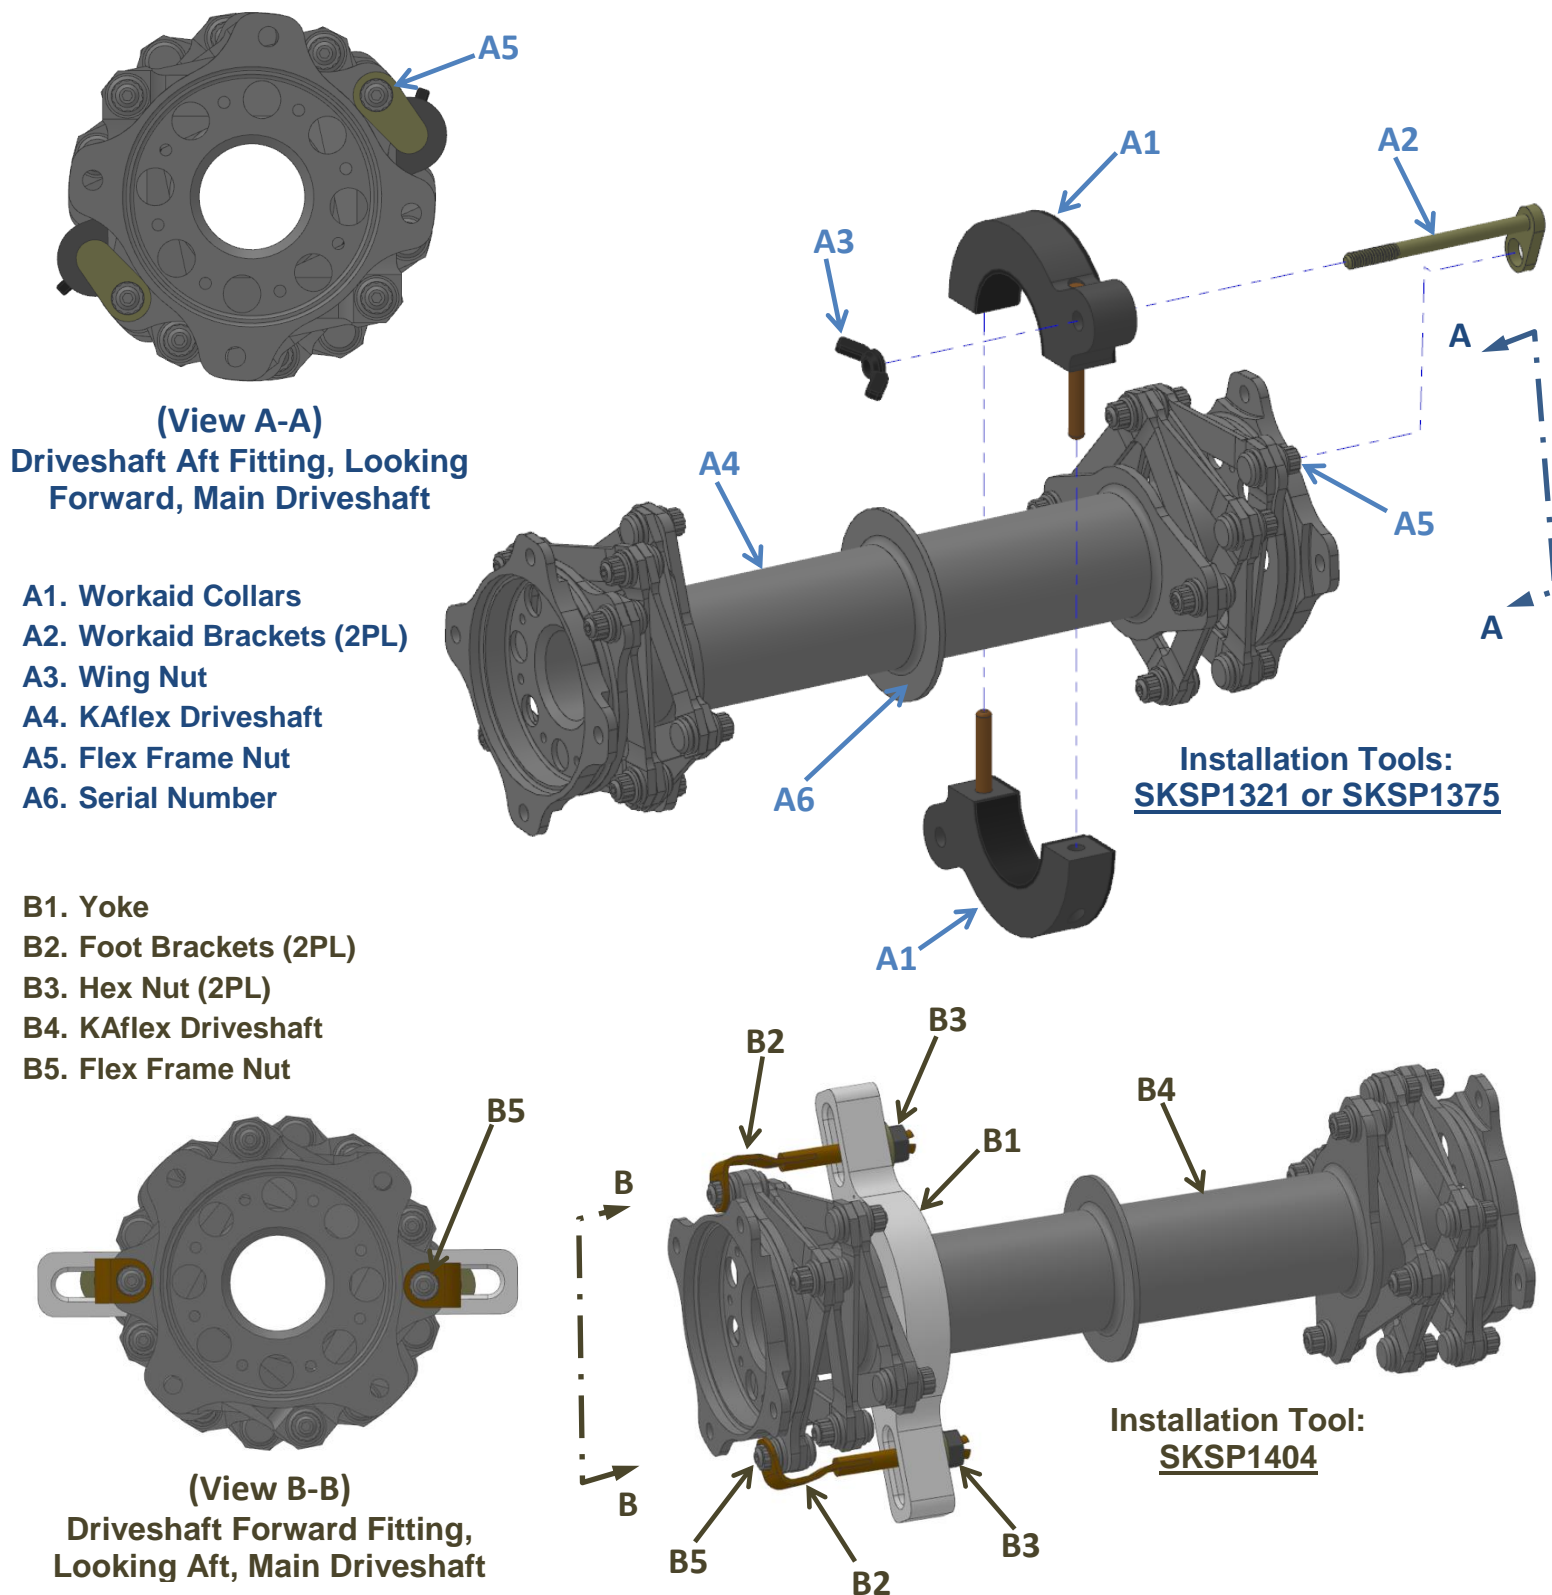
**FIGURE 1: Installation of Workaid
(Installation Tool SKSP1321, SKSP1375 or SKSP1404)**

- c. If the caliper assemblies have not been brought in accordance with BHT Service Instruction Number 207-87-120, Dual Caliper Rotor Brake Assembly, Modification of, for removal of asbestos caliper pads, remove the calipers and make them compliant to the technical bulletin at this time.
- d. Install Workaid on driveshaft as shown in Figure 1 and compress forward frames.
- e. Remove clear rust inhibiting coating from SKCP2962 Rotor Brake Disk with acetone.

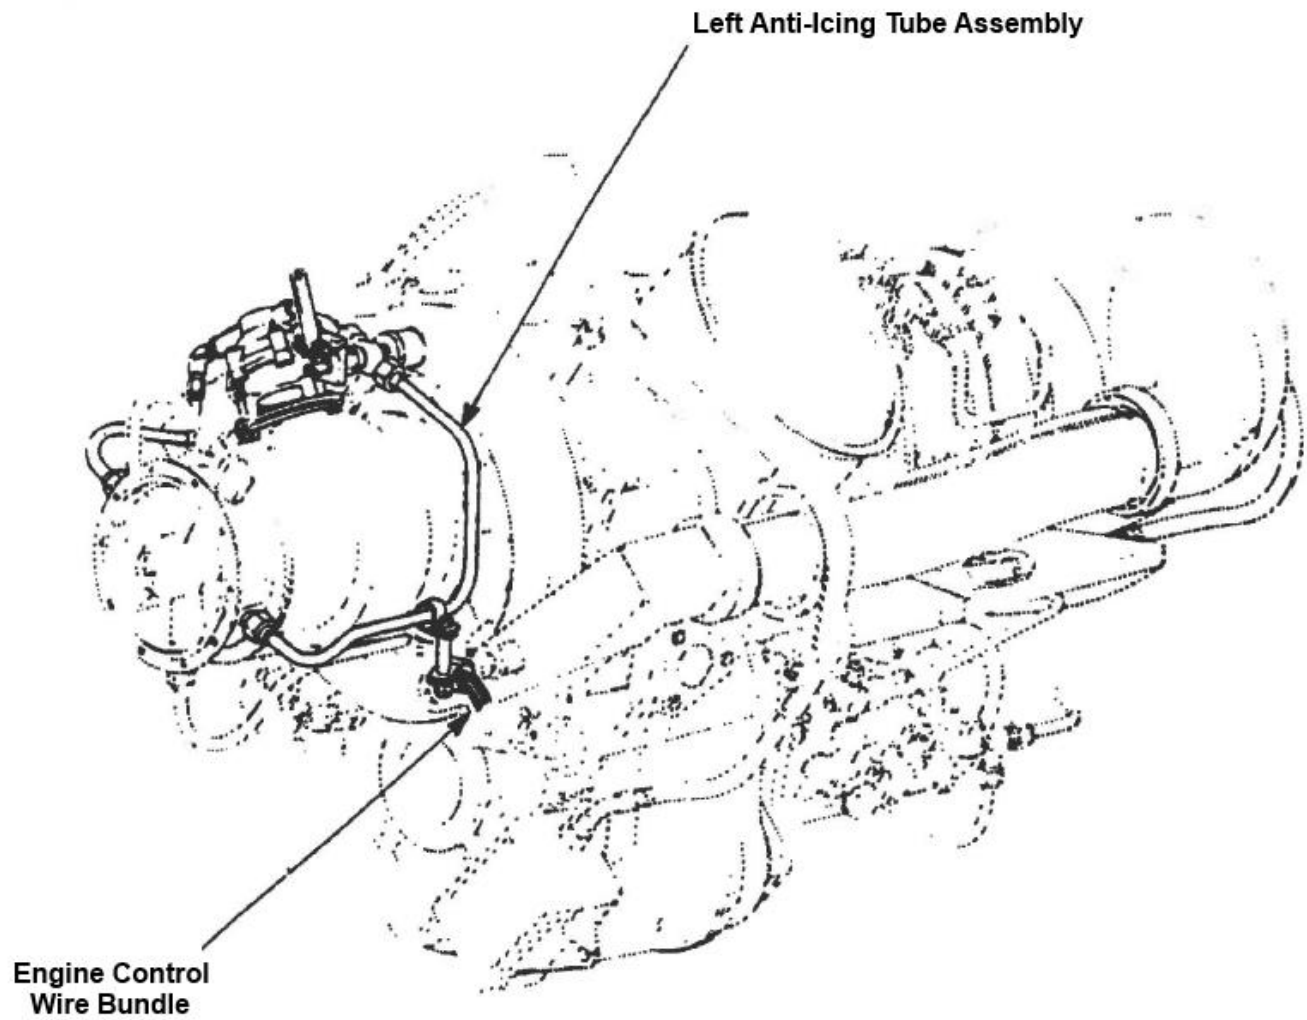
FIGURE 2: Optimum Location of Engine Control Wire Bundle on Left Anti-Icing Tube Assembly

- f. Install SKCP2962 Rotor Brake Disk on SKCP2967 Cup using 8 AN3-5A bolts and associated hardware as shown on View C Sheet 2 of SKCP2975 in Section 5.
- g. Refer to Figure 2. Loosen the wire clamp holding the engine control wire bundle to the left-hand anti-icing tube assembly shown in Figure 2. Slide the clamp aft as far as necessary to ensure that wires will not contact the rim of the KAFlex Rotor Brake Disk. Verify that adequate wire slack still exists, and tighten clamp in the new position.

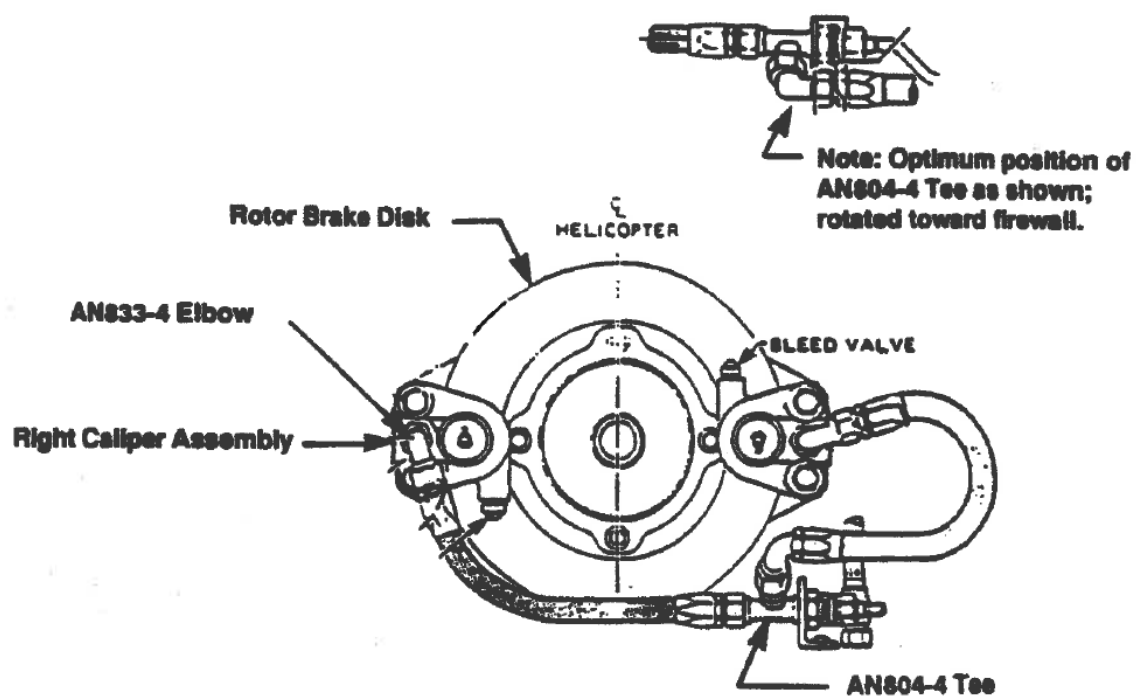
TOP VIEW

FIGURE 3: View Looking Aft at Rotor Brake

- a. Certain items must have their positions adjusted to allow clearance of the caliper assemblies upon reinstallation. Refer to Figures 3 and 4. Figure 3 shows the optimum position of the AN804-4 Tee. Verify that the tee is in this position, or loosen it just enough to allow slight rotation without permitting air to enter the hydraulic system at this fitting. If the aircraft does not have a particle separator installed, proceed to Step b at this point. Figure 4 shows the AN834-6 Tee which connects the compressor bleed air line to 206-061-222-1 Tube Assembly across the firewall to allow this fitting to be installed in its most forward position. Reconnect the lines.
